TECHNICAL MEMORANDUM

City of Alexandria Storm Sewer Capacity Analysis

Task Order 2D – Heavy Cleaning & CCTV (N. Beauregard St)

Storm Pipe Segment: 001316STMP

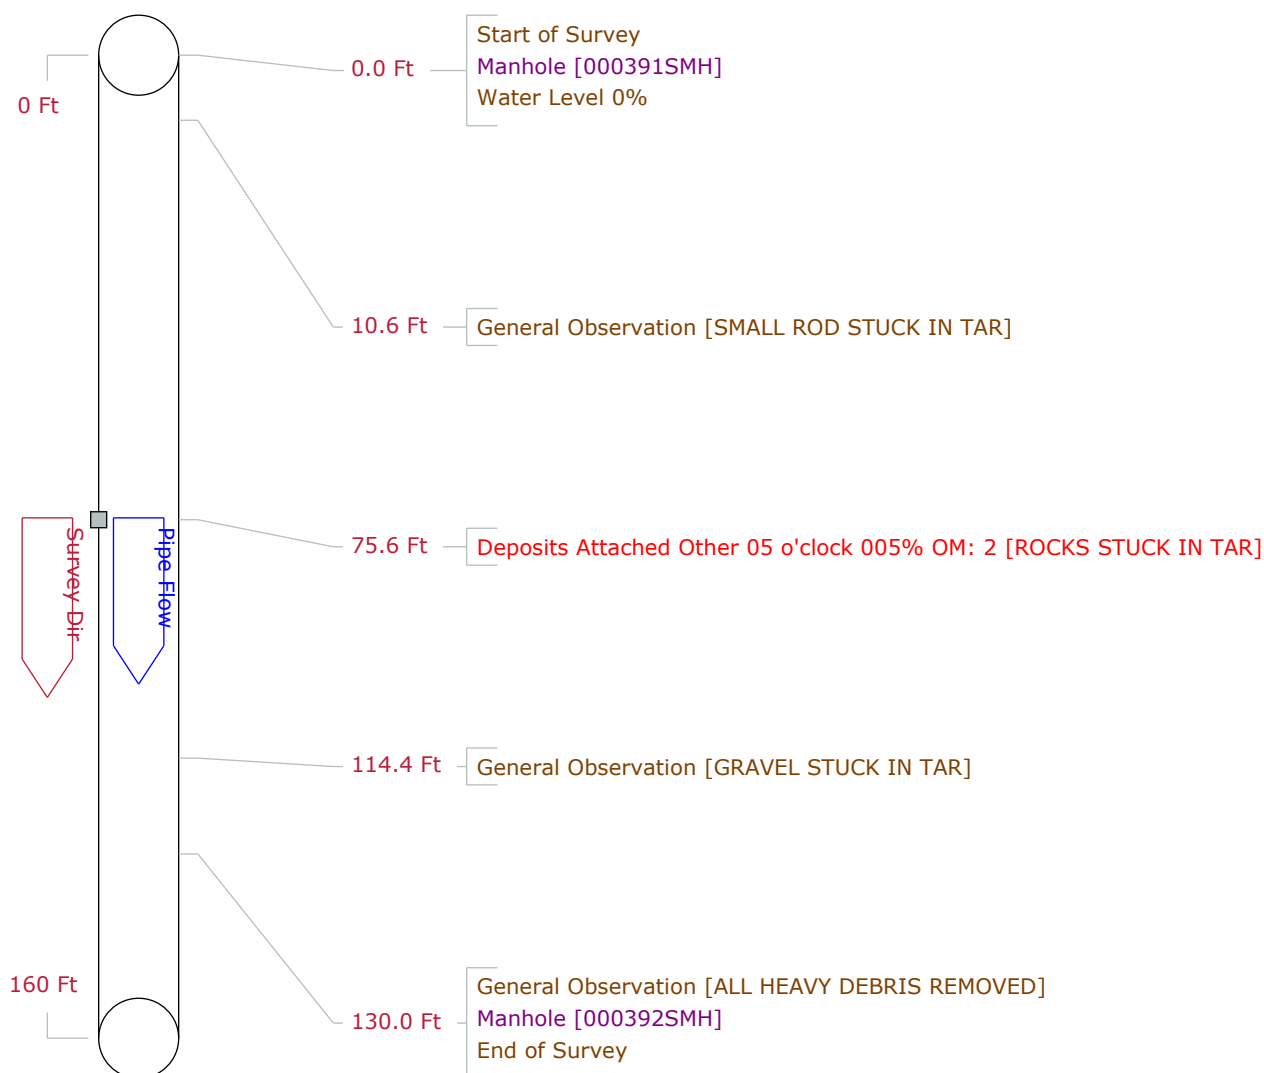
Pipe Graphic Report of PSR 000391SMH X for CH2M HILL

VPS inspected 130 linear feet of 57-inch diameter tar-lined corrugated metal pipe. No significant structural defects were observed in the pipe; small amounts of sand and gravel were observed embedded in the tar lining.
